# Manhole Inspection Summary

Manhole # S17EE2023MH

**Location** Address: **1700 KELLY AVE**

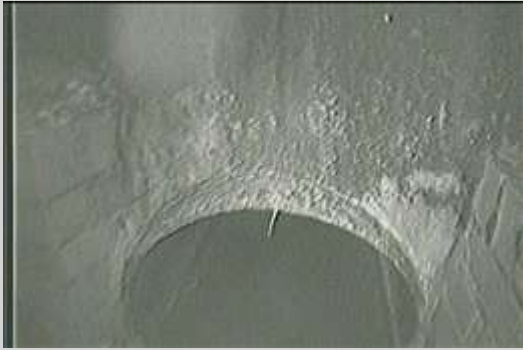
### 18 in. Circular Gravity Sewer

Invert Depth: **18.14** (ft.) Flow Characteristics: **None**

Infiltration: **None** Pipe Seal Cond: **Unknown**

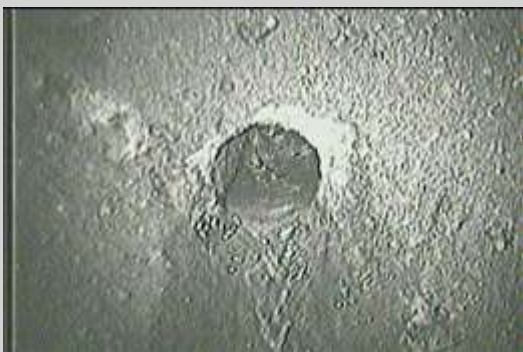
### 4 in. Circular Gravity Sewer

Infiltration: **None** Pipe Seal Cond: **Unknown**
